FINAL HYDROGRAPHIC SURVEY REPORT  
FOR THE  
**REGIONAL SCALE NODES (RSN) COMPONENT**  
**OF THE OCEAN OBSERVATORIES INITIATIVE (OOI)**

**REGIONAL SCALE NODES PROGRAM OFFICE**

**JANUARY 14, 2011**

**L-3 COMMUNICATIONS MARIPRO, INC.**

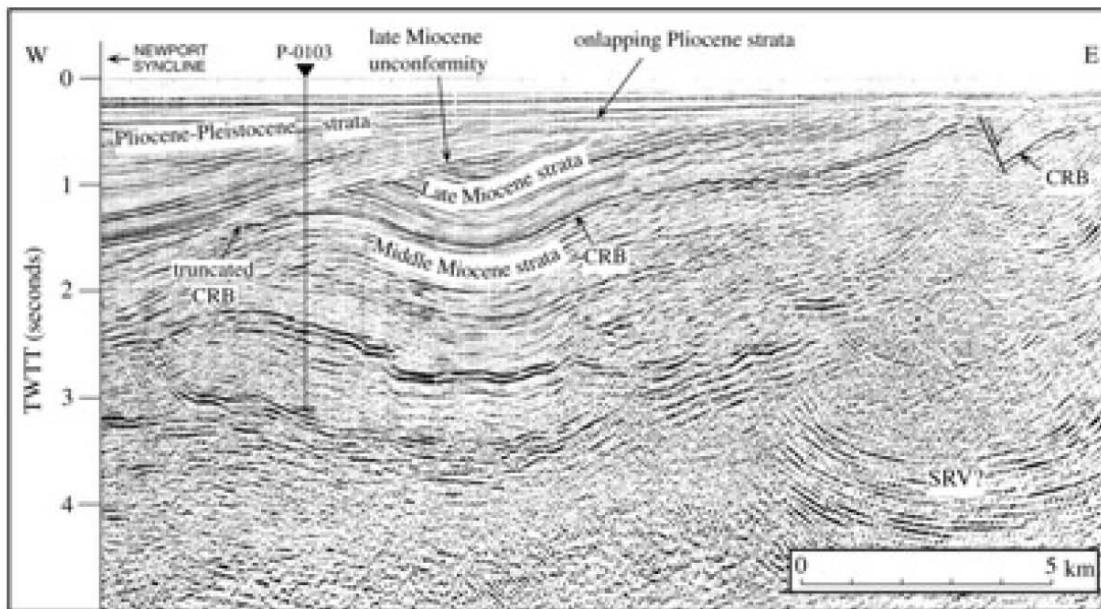
FIGURE 4-3 2D SEISMIC PROFILE OF SHELF

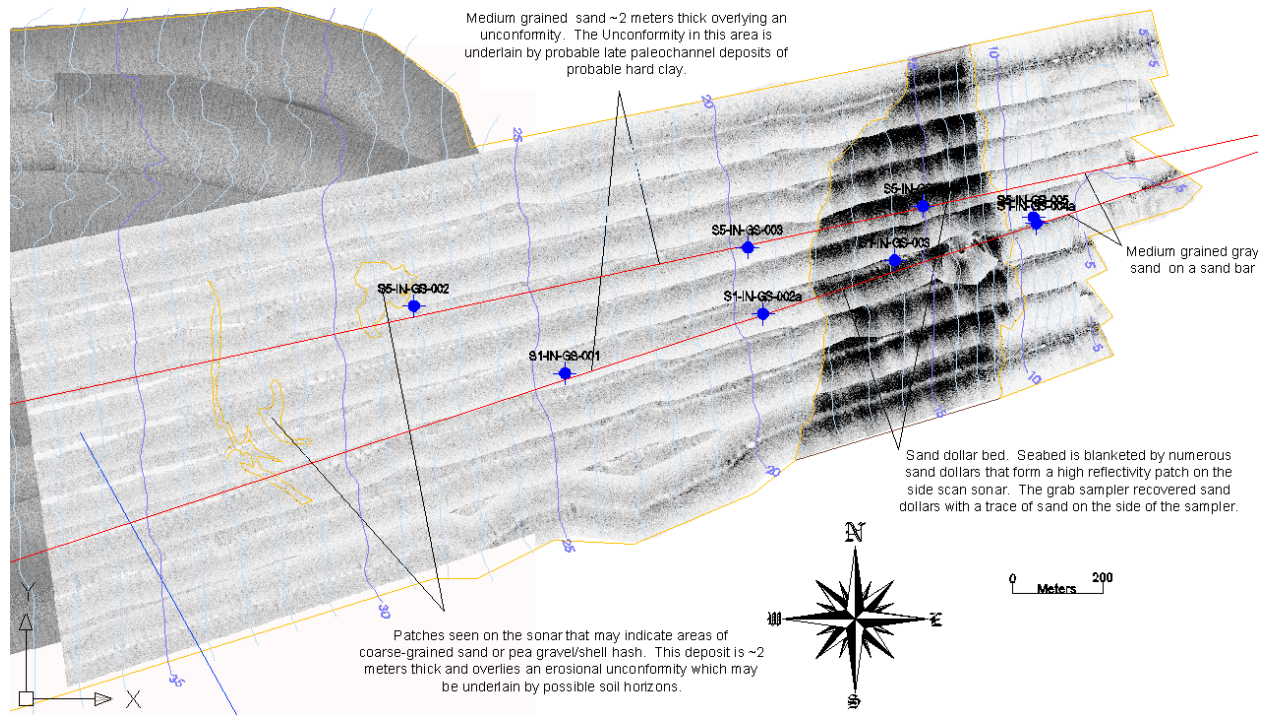
FIGURE 5-1 BATHYMETRY AND INTERPRETED SEABED FEATURES OF THE INSHORE SURVEY CORRIDOR

Sand dominates the Inshore survey corridor, but beginning approximately 900 m from the BMH, Segments 1 and 5 encounter the first of several gravel patches. The first, extending some 430 m, was blanketed with sand dollars during the survey, and appears as an extremely high reflectivity patch on the side scan recordings. This is not an unusual feature, as sand dollars have been mapped with side scan sonar in other places along the Pacific coast of the United States (e.g. Fenstermacher *et al.*, 2001). Sand dollars tend to cluster in areas where food sources and physical environments are favorable. It is therefore difficult to predict whether this patch is stable or transitory. Appearing more like ribbons, the other gravel (or coarse-grained sand) patches are clustered approximately 2550 m from the BMH between the 28 and 34 meter isobaths, none spanning more than 30 m along either route (Figure 5-1, RSN.S1.NU.CHART-001 and RSN.S5.NU.CHART-001).

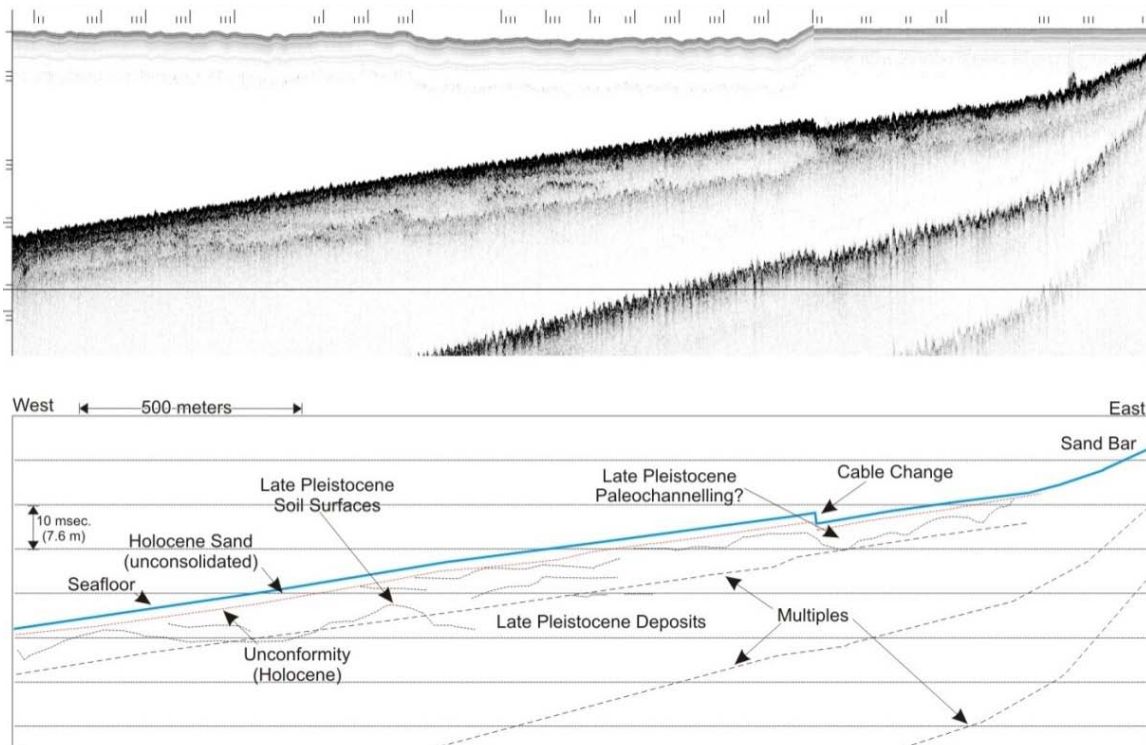
FIGURE 5-2 INTERPRETED SUBBOTTOM PROFILES OF THE INSHORE CENTERLINE OF SEGMENT 1

Although the local members of the Angora Peak Fm and the strata it overlays plunge seaward from the Pacific City region (see §4.2.2), the subbottom profiler data does not reveal them. Instead, the inshore corridor appears to comprise recent beach deposits unconformably overlying older strata and soil horizons with probable paleochannelling. These older sediments probably consist of sand and gravel/shells, and several apparent soil horizons – possibly containing firm to stiff clay, gravel/shells or other compacted sediments – obliquely intersect the unconformity. This interpreted erosional surface is about 1 m below the seabed near the 40 m isobath and 2 m at the 20 m isobath, but does not appear in the subbottom profiles shoreward of the 20 m isobath, possibly due to acoustic scattering from the sand dollars. Figures 5-2 and 5-3 show the interpreted profiles of the centerlines for both Segments 1 and 5.

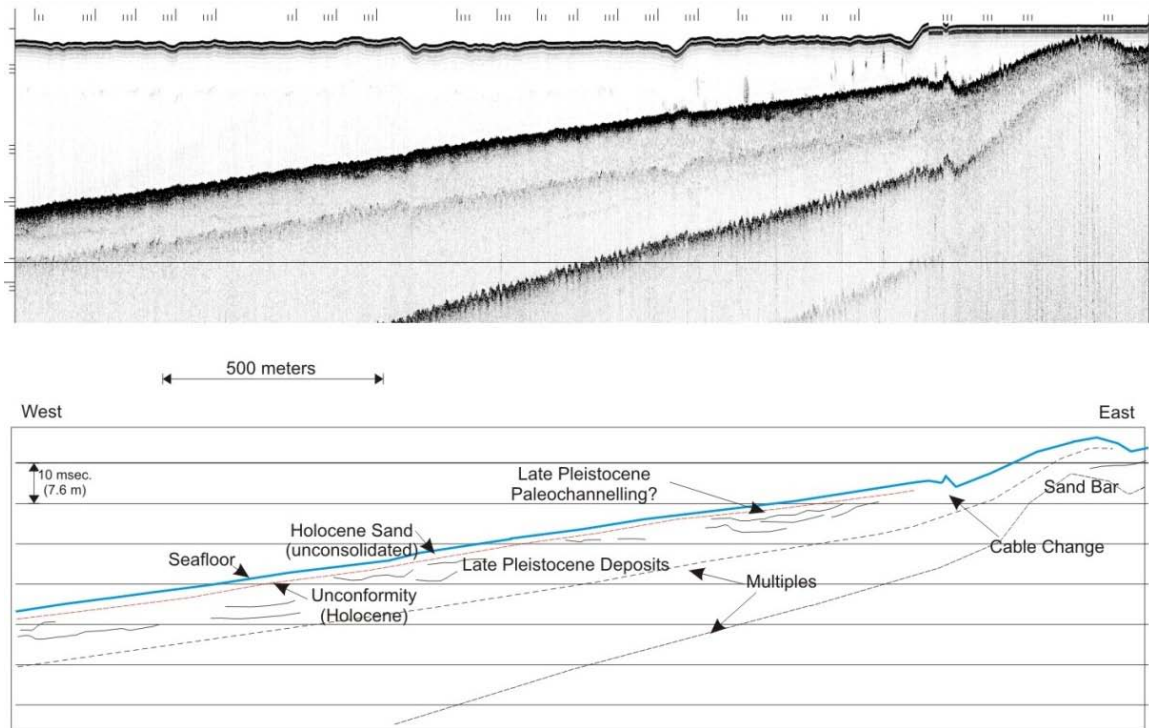
FIGURE 5-3 INTERPRETED SUBBOTTOM PROFILES OF THE INSHORE CENTERLINE OF SEGMENT 5

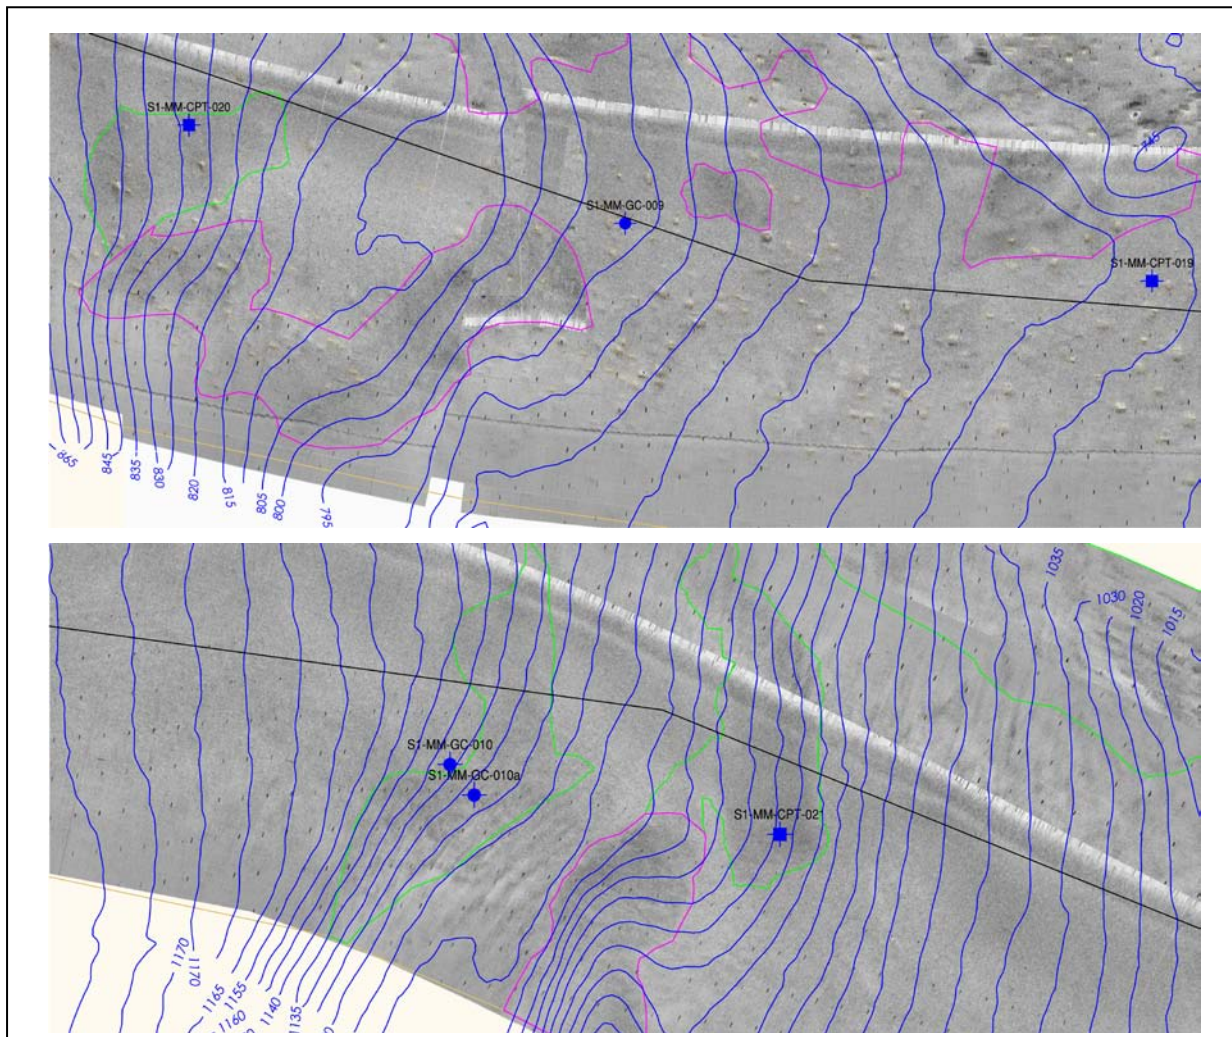
FIGURE 5-8 SIDE SCAN IMAGES OF OUTCROPPING STRATA AND BEDROCK

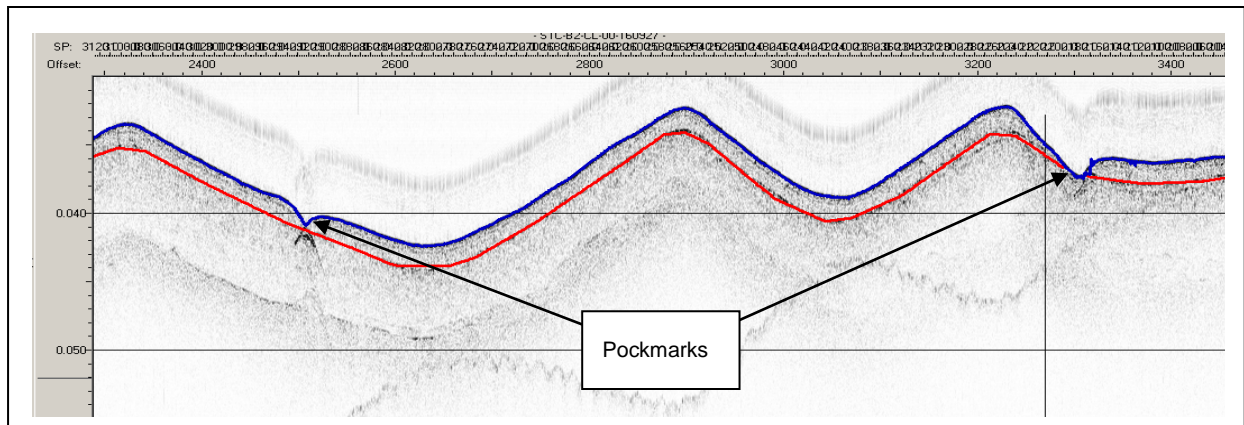
FIGURE 5-10 SUBBOTTOM IMAGES OF SEGMENT 1 (POCKMARKS)

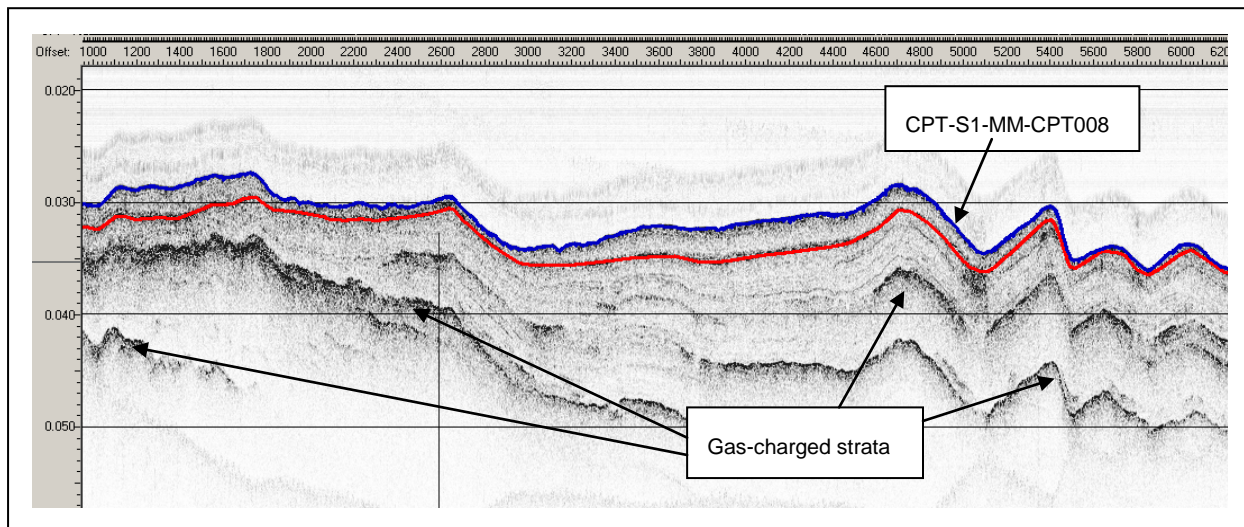
FIGURE 5-11 SUBBOTTOM IMAGES OF SEGMENT 1 (GAS-CHARGED STRATA)

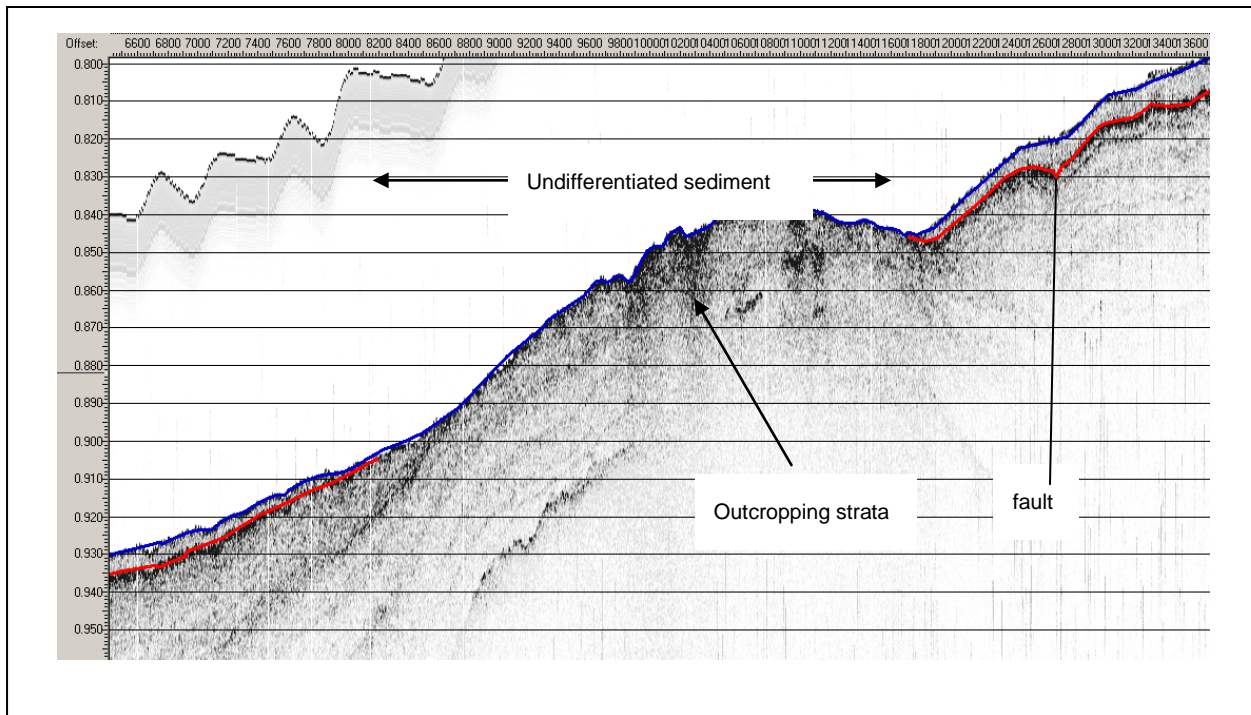
FIGURE 5-13 SUBBOTTOM PROFILE OF LINE S1C-B3-N250-RB-00

Subbottom profile of Line S1C-B3-N250-RB-00 showing exposure of older undifferentiated sediment and strata and overlying sedimentary cover (red line) to either side. A normal fault is visible at right. Vertical scale lines are 10 msec. (labeled in seconds) 'Offset' indicates horizontal distance in meters southwest is towards the left.

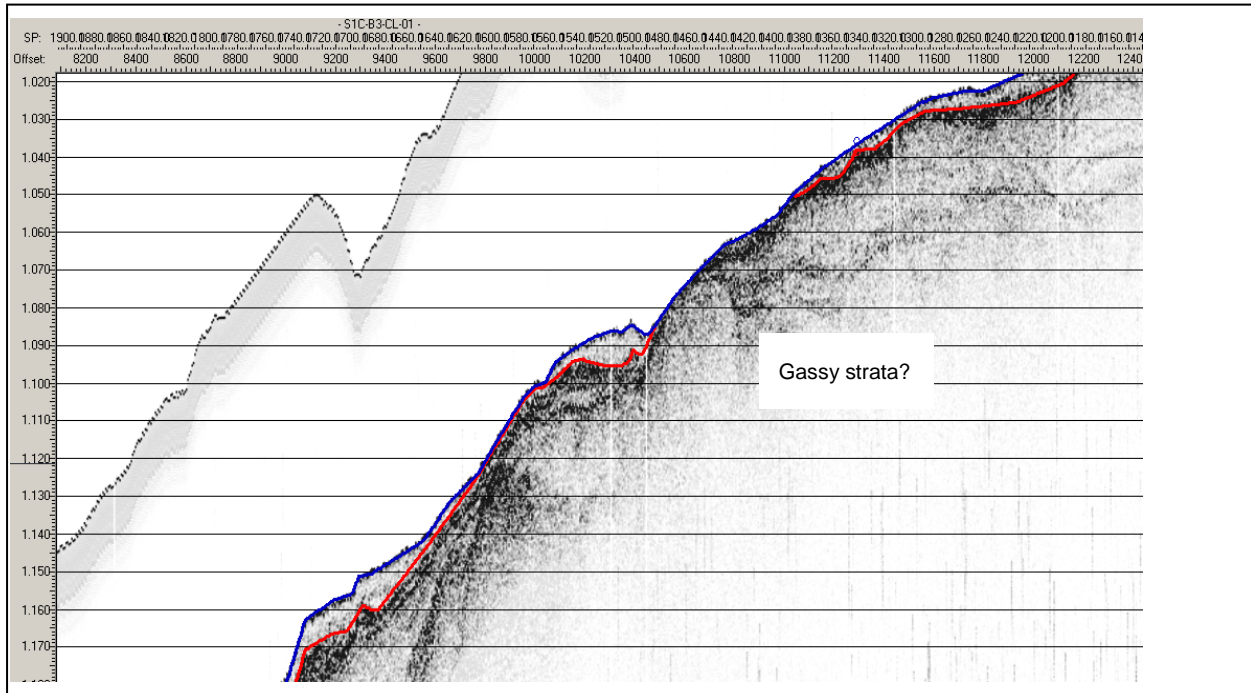
FIGURE 5-14 SUBBOTTOM PROFILE OF LINE S1C-B3-CL-01

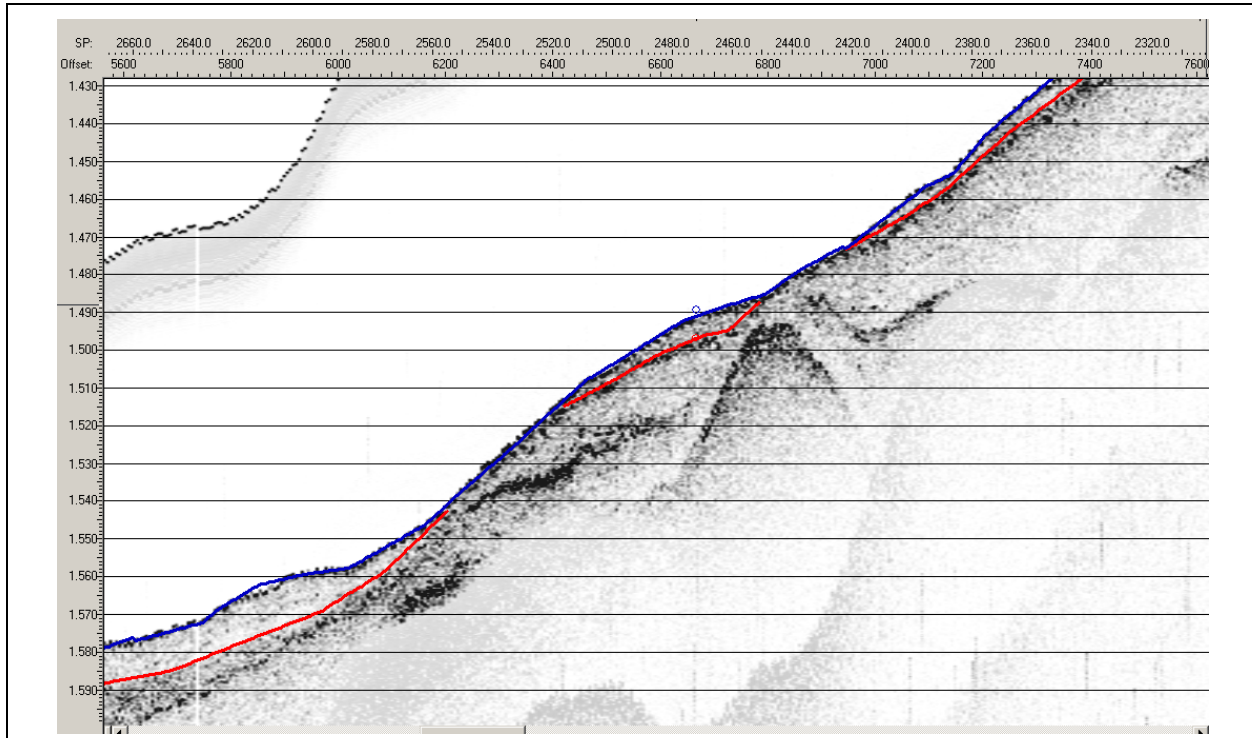
FIGURE 5-15 SUBBOTTOM PROFILE OF LINE S1C-B3-CL-01TO02SNP

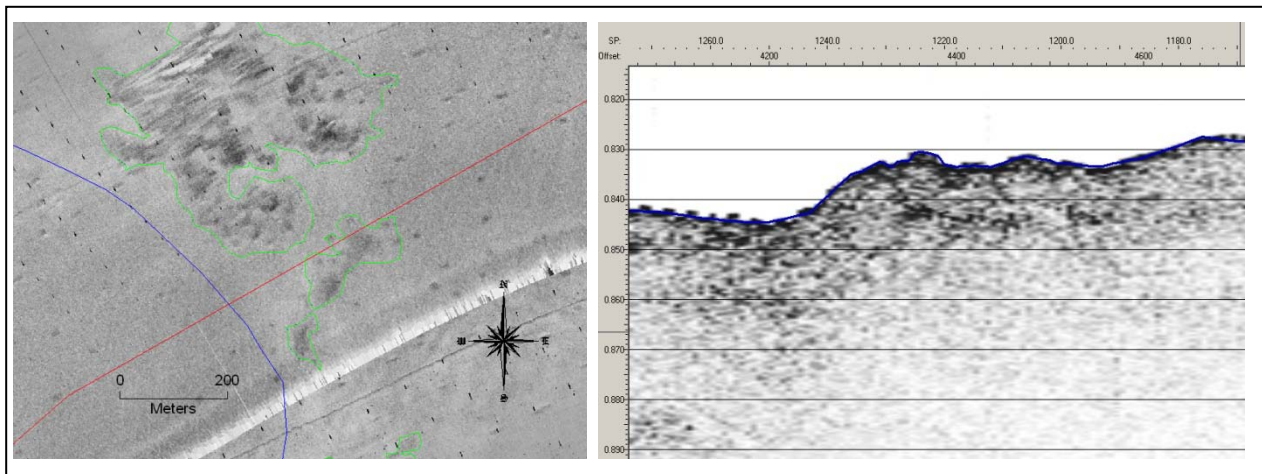
FIGURE 5-16 AREAS OF CONCERN S1-A

Of chief concern in this area is the presence of bottom contact fishing scars in places where the thickness of the soft sedimentary cover is too thin to be measured from the subbottom record. The numerous pockmarks here (Figure 5-16) suggest there is some surficial sediment, but nothing shows in the subbottom profile to verify that conclusion. The outcropping strata are evident as highly reflective patches on the sonar record. To the north, these strata form ledges with acoustic shadows. The outcropping strata are surrounded by undifferentiated sediment that may be stiff to hard. Surficial unconsolidated silt/clay is present southwest of the blue line in Figure 5-16. Burial may be difficult in this area.

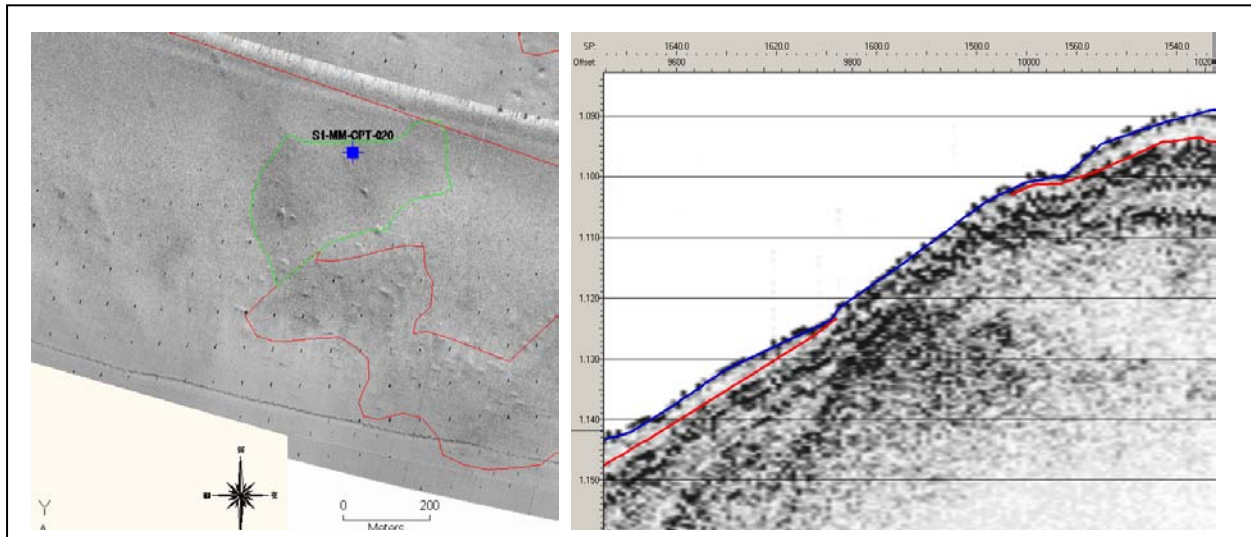
FIGURE 5-17 AREA OF CONCERN S1 B

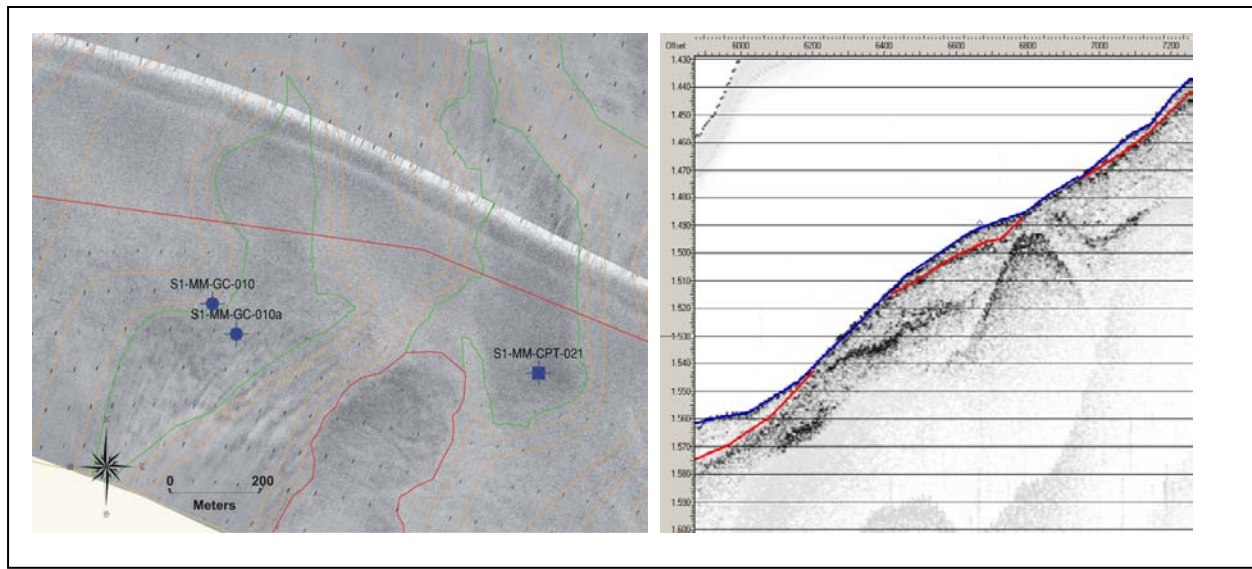
FIGURE 5-18 AREA OF CONCERN S1 C

Like S1 b, this area is called out for its exposures of strata (Figure 5-18). Gravity core S1-MM-GC-010 achieved no penetration. Gravity core S1-MM-GC-010a achieved 2.4 m of penetration and described stiff sandy clay. CPT S1-MM-CPT-021 was acquired within the outcropping strata and achieved 1.87 m of penetration before the instrument failed and recorded stiff/dense material.

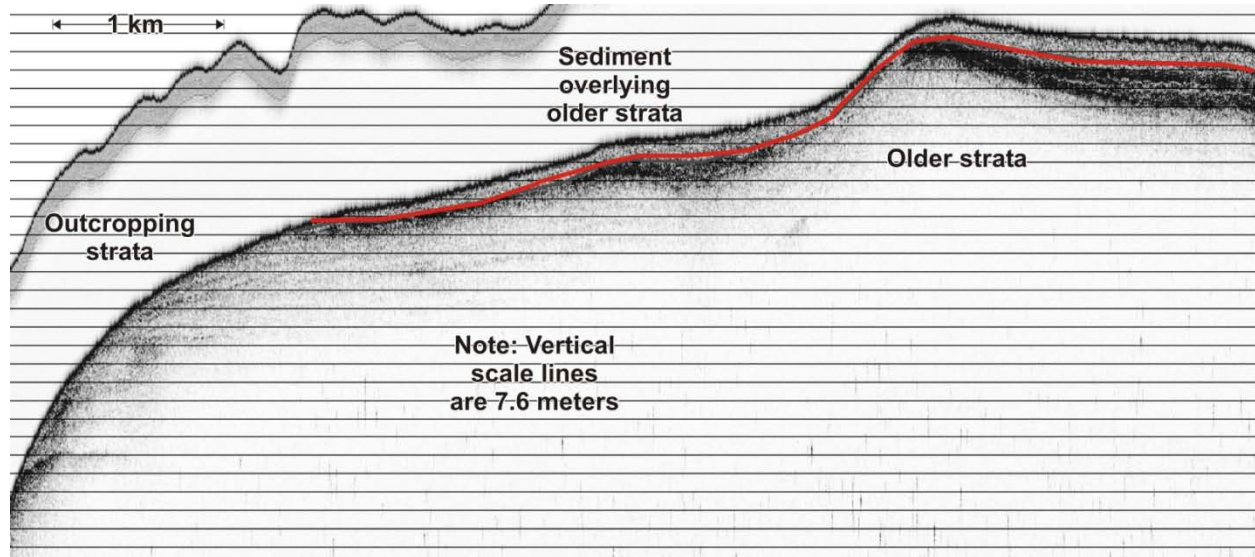
**FIGURE 5-20 SUBBOTTOM PROFILE SEGMENT 2**

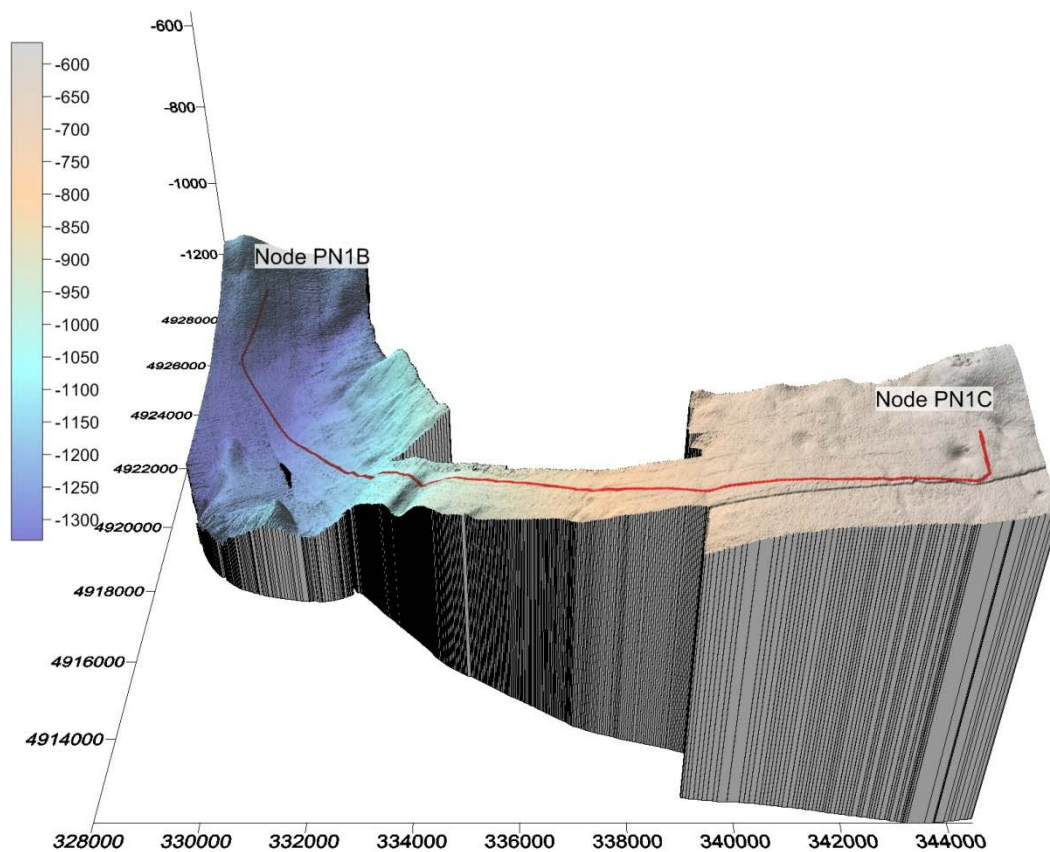
FIGURE 5-21 SEGMENT 3 TOPOGRAPHY

The final-survey route deviated significantly from the pre-survey route for this segment, as Primary node PN1C was relocated some 29.6 km to the south-southwest. From Primary Node PN1B, Segment 3 of the RSN route heads to the south, then progressively turns eastward as it steadily ascends the southwestern slope of Southeast Knoll (Figure 4-1), where gradients are less than 5.5% (3.1°; RSN.S3.NU.CHART-001A). Segment 3 ends at Primary Node PN1C on a gently sloping terrace near the 616 m isobath. The only topographic feature on the route is a large seabed crater (~230 m diameter and 6 m deep) located at the eastern end of the route, about 825 m southwest of Primary Node PN1C. The planned route curves around the south and east side of this crater on approach to Primary Node PN1C (see chart RSN.S3.NU.CHART-004B). Figure 5-21 depicts the topography along Segment 3.

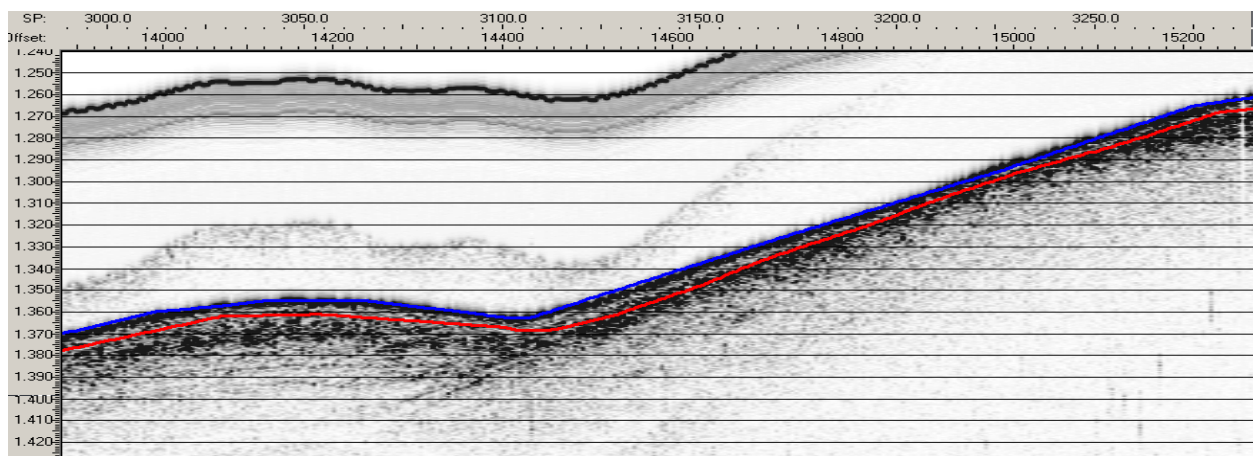
FIGURE 5-23 SEGMENT 3 SUBBOTTOM PROFILER IMAGE

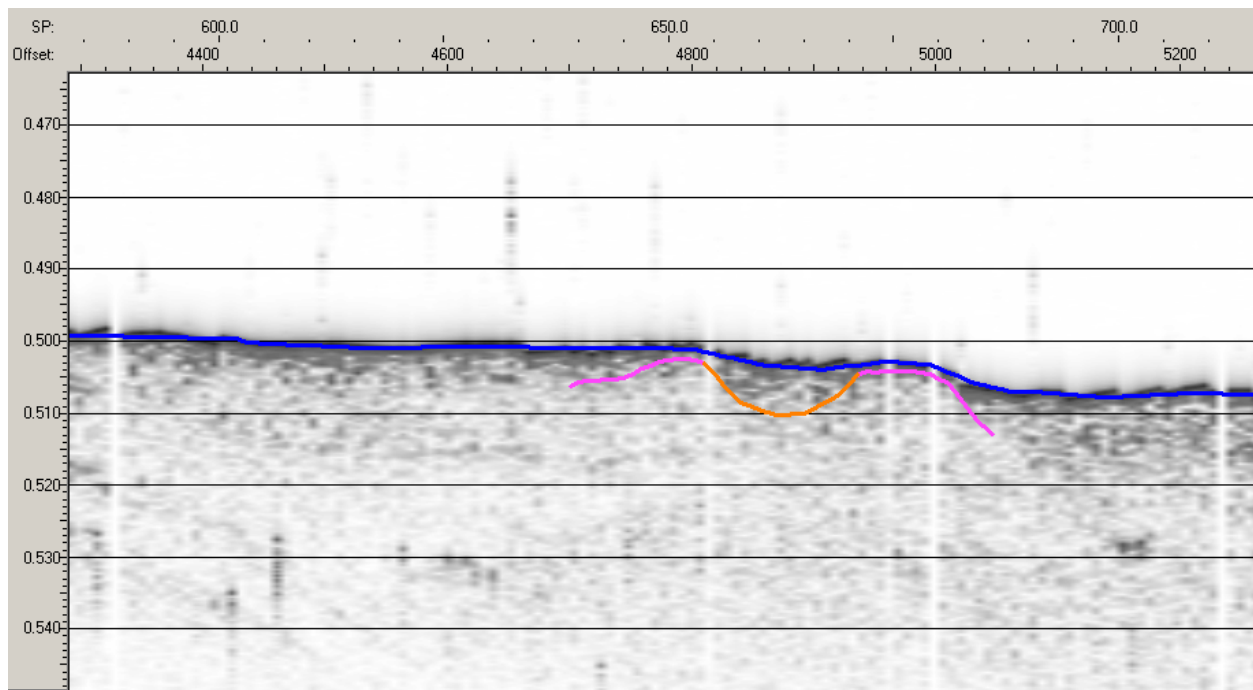
FIGURE 5-29 SUBBOTTOM PROFILE SEGMENT 4 TURBIDITE CHANNEL

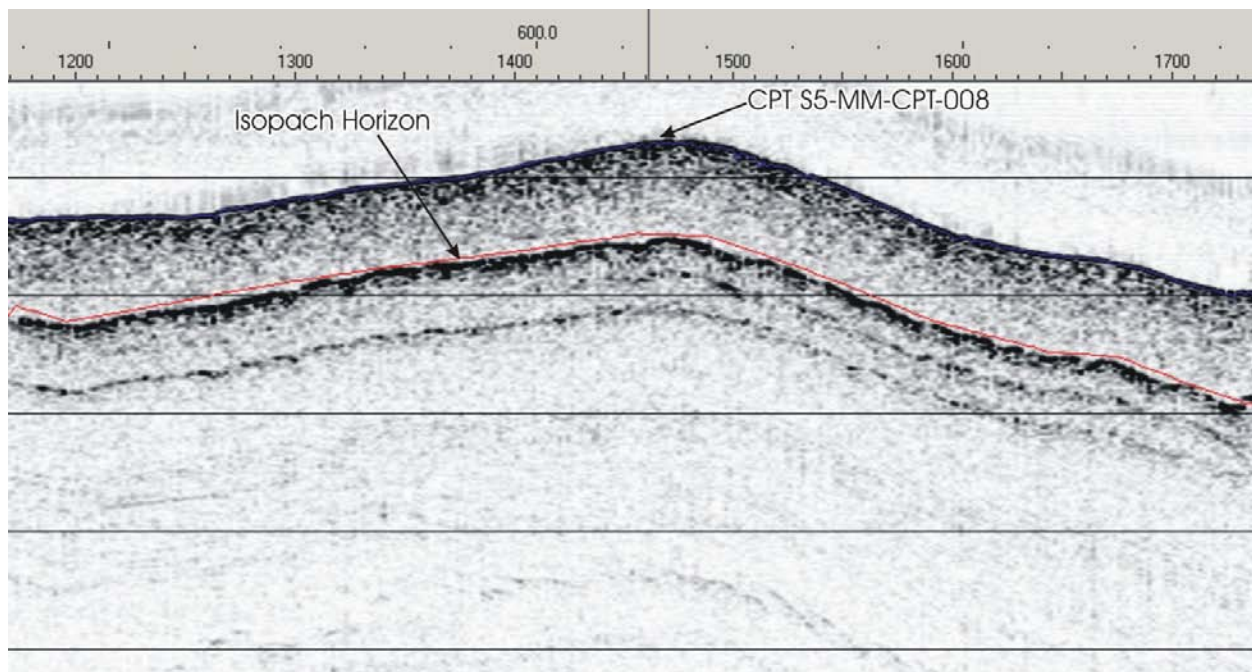
FIGURE 5-44 SUBBOTTOM PROFILE SHOWING SURFICIAL SEDIMENT AND UNDERLYING REFLECTORS

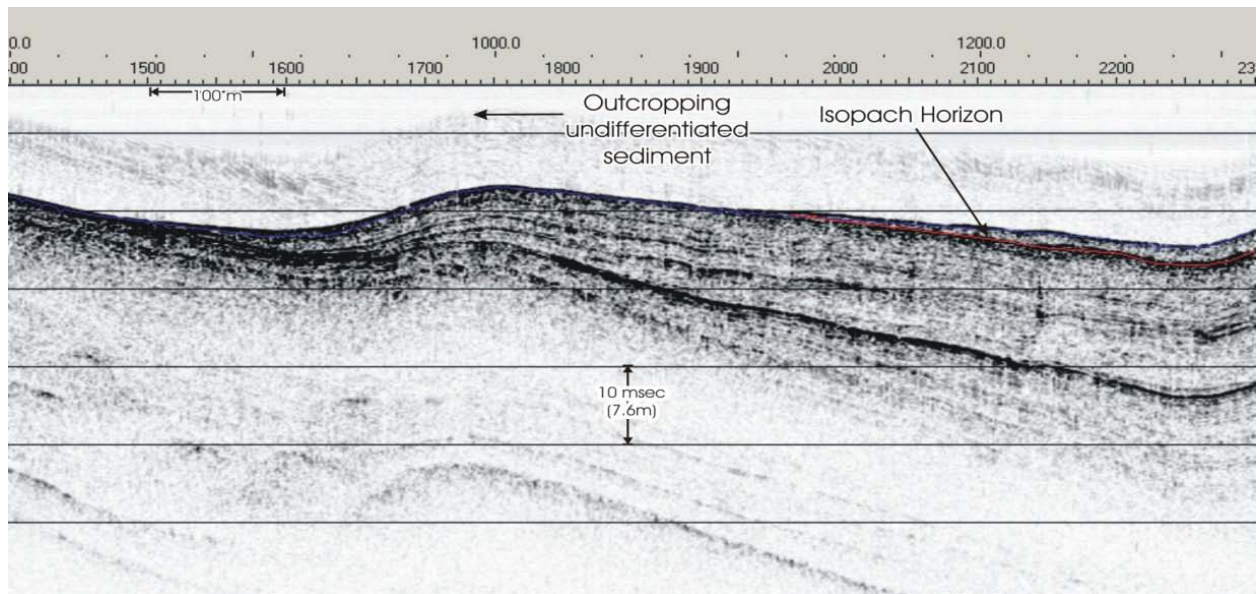
FIGURE 5-45 SUBBOTTOM PROFILE SHOWING PINCH-OUT OF SURFICIAL SEDIMENT

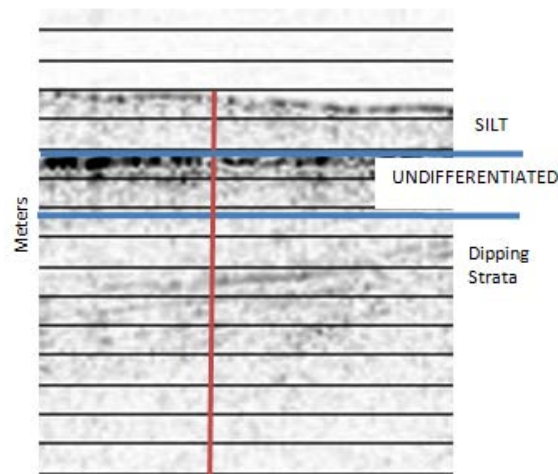
FIGURE 10-1 SUBSURFACE CHARACTERISTICS BY CPT, GRAVITY CORE AND SBP
